Subject: US Gulf Coast Marine Fuel Incidents March to July 2023

The CIMAC Fuels working (WG7) group consists of experienced stakeholders representing refiners, suppliers, traders, and fuel producers for both petroleum and biogenic sourced fuels, along with the machinery OEMs, ship operators, fuel testing labs and classification societies.

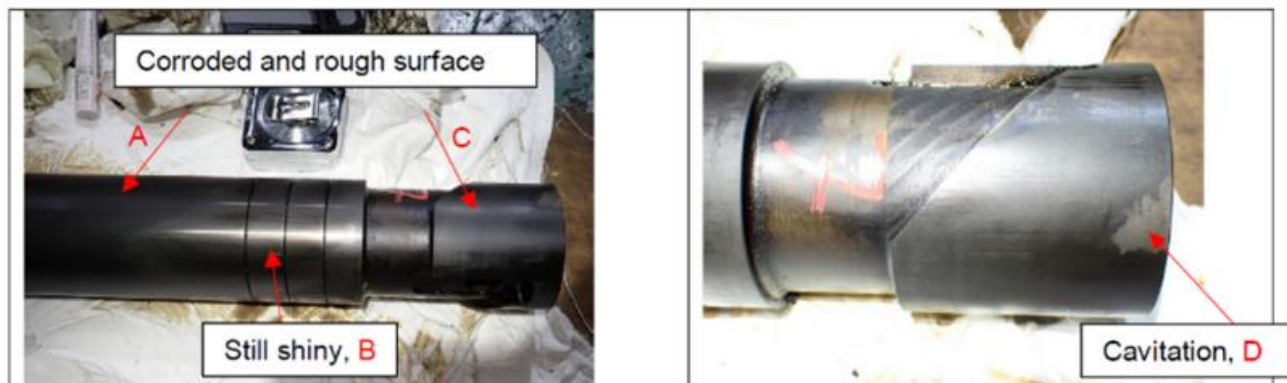
Figure 1 illustrates a typical case study showcasing the prevalent issues of fuel pump deterioration reported.

Figure 1: Fuel plungers and barrels were dismantled from the fuel pump on all cylinder units of the main engine on one ship. The top area of all fuel plungers was found corroded and the fuel pump could not be re-used. The corrosion leads to leakages between plunger and barrel, jeopardising the fuel injection due to reduced compression efficiency.

We reiterate the importance that blend components should be verified as 'bunker-suitable' before blending and the infrastructure and procedures to prevent contamination (e.g. line flushing) should be in place. The fuel shall not contain harmful or damaging materials in concentrations that may cause damage to machinery as defined in Clause 5 of ISO 8217:2017, in place at the time of delivery, and Regulation 18.3 of MARPOL Annex VI. If it is established that the supplied fuel is accountable for operational issues experienced, it would then indicate that the bunkers did not meet the ISO 8217 standard.
